Manhole Inspection Summary

Manhole # S11GG1009MH

Insp Date: **2/5/09 11:26 AM**

Location Address: **2920 BOARMAN AVE**

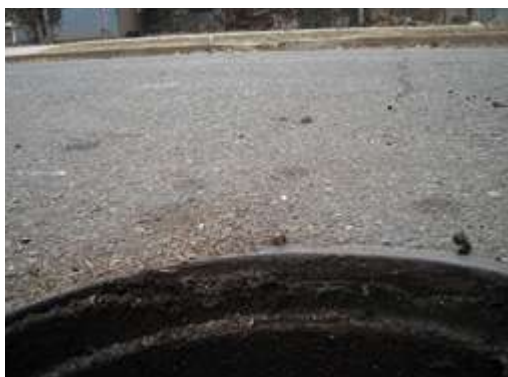
EVIENCE OF INFLOW DUE TO
SHEETING FROM CROWN OF
ROADWAY

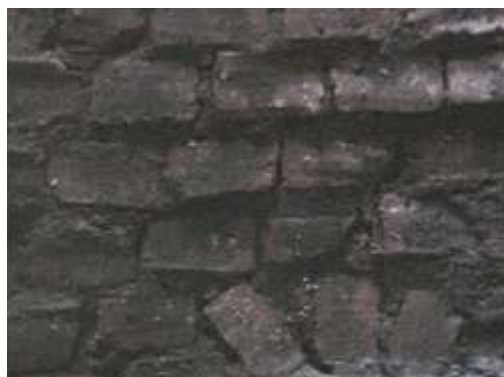
Defect 6

CRACKED BRICKS IN DETERIORATED
BARREL-INFILTRATION

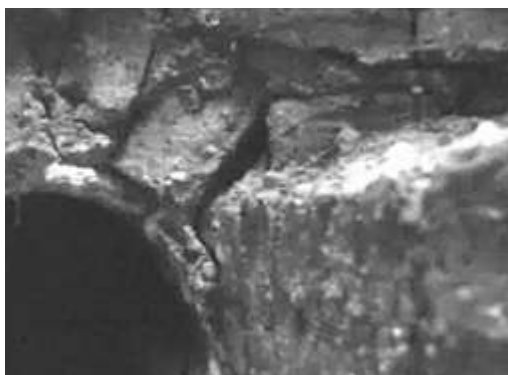
Defect 5

MISSING MORTAR IN DETERIORATED
PIPE SEAL

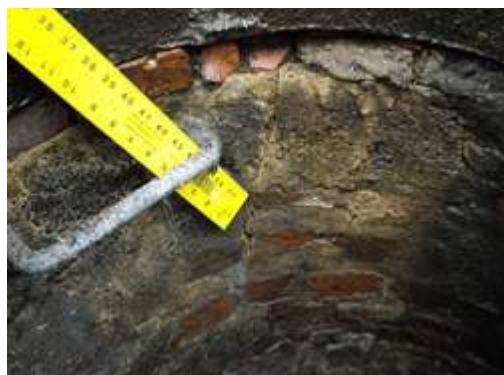
Defect 1

CORBEL WALL HAS 1FT CRACK AT TIP
OF YELLOW RULER-INFILTRATION

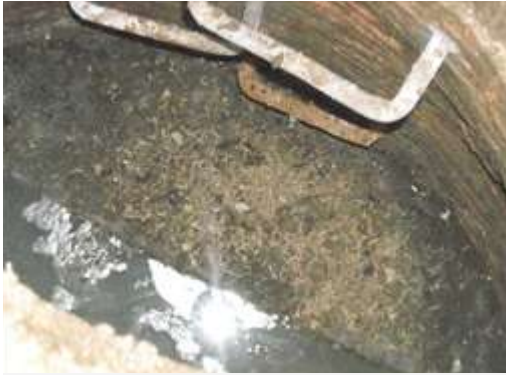
Defect 4

DEBRIS ON BENCH

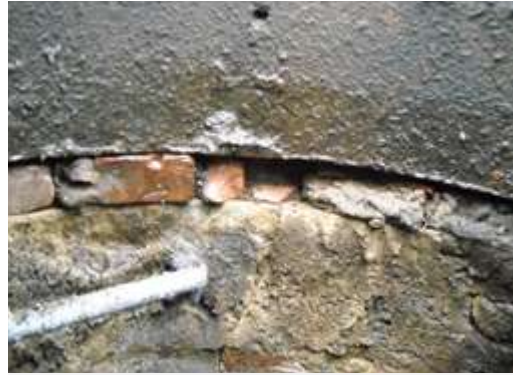
Defect 2

MISSING BRICKS IN CHIMNEY AND
DETERIORATED AND MISSING
MORTAR

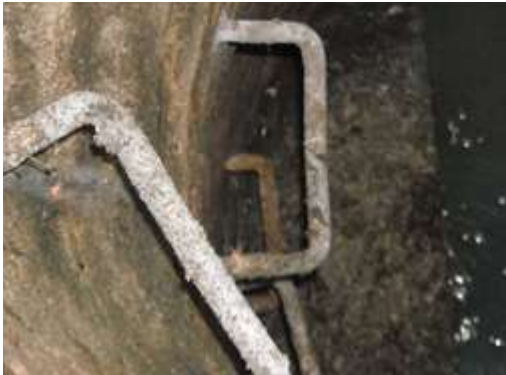
Defect 3

CORRODED BOTTOM STEP

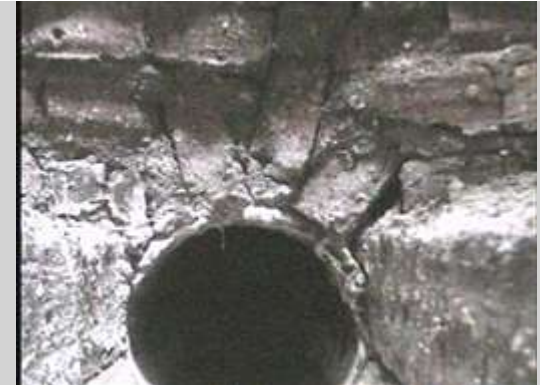
12 O'Clock Outflow

Pipe Height: **8.4** (in.) Rod and Bar (Angled)
Pipe Material: **Clay** ☐ Pipe Lined
Invert Depth: **9.17** (ft.) Flow Characteristics: **Slow**
Deposits: ☒ None ☐ Mud ☐ Sludge ☐ Debris ☐ Grease
Silt Depth: (in.) Deposits Extent:
Infiltration: **None** Pipe Seal Cond: **Cracked**

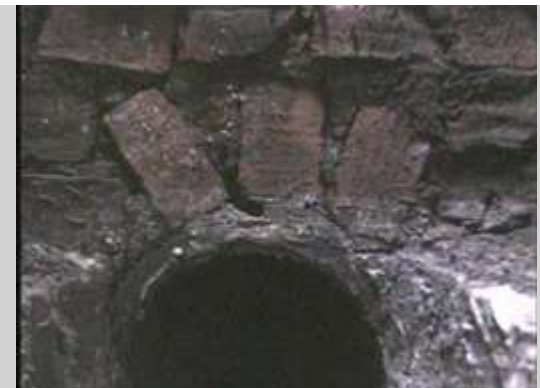
6 O'Clock Inflow

DETERIORATING PIPE SEAL MISSING
MORTAR

Pipe Height: **8.4** (in.) Rod and Bar (Angled)
Pipe Material: **Clay** ☐ Pipe Lined
Invert Depth: **9.08** (ft.) Flow Characteristics: **Slow**
Deposits: ☒ None ☐ Mud ☐ Sludge ☐ Debris ☐ Grease
Silt Depth: (in.) Deposits Extent:
Infiltration: **None** Pipe Seal Cond: **Cracked**
